INDOOR AIR QUALITY ASSESSMENT

**Hampshire Regional High School
19 Stage Road
Westhampton, Massachusetts**

Prepared by:
Massachusetts Department of Public Health
Bureau of Environmental Health Assessment
January 2003

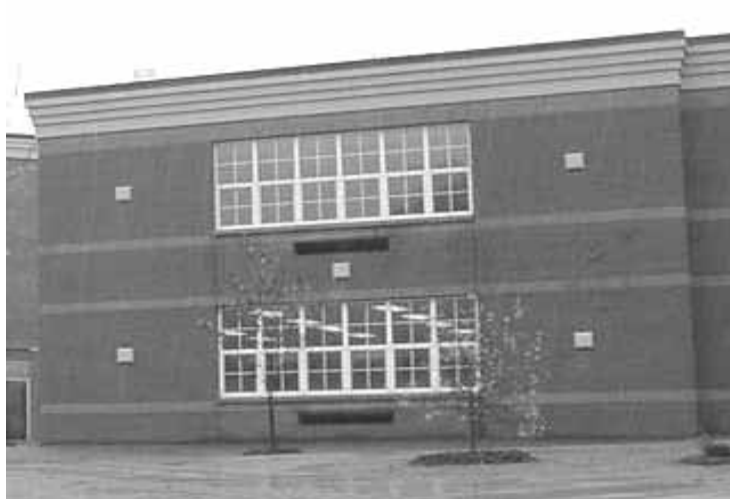
Picture 1

New North Wing

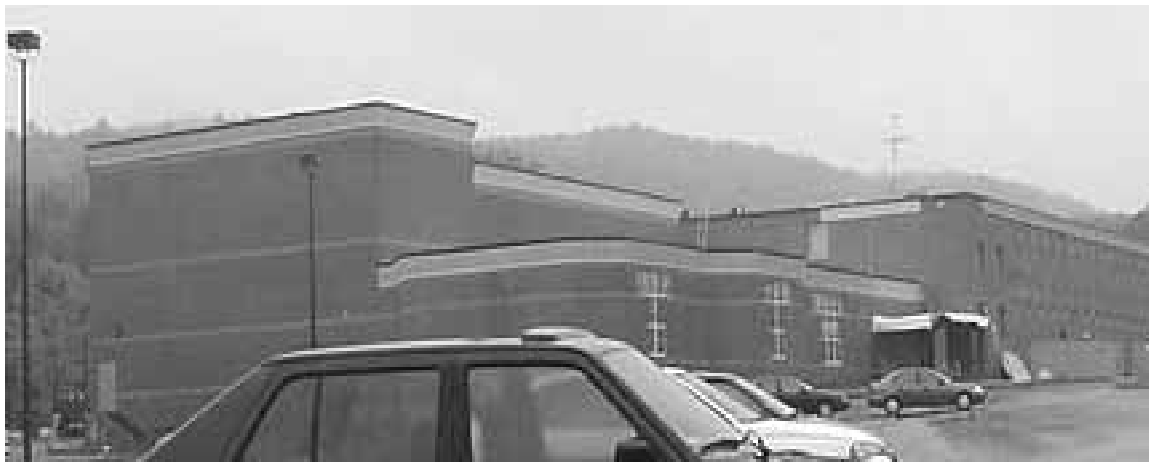
Picture 2

New South Wing

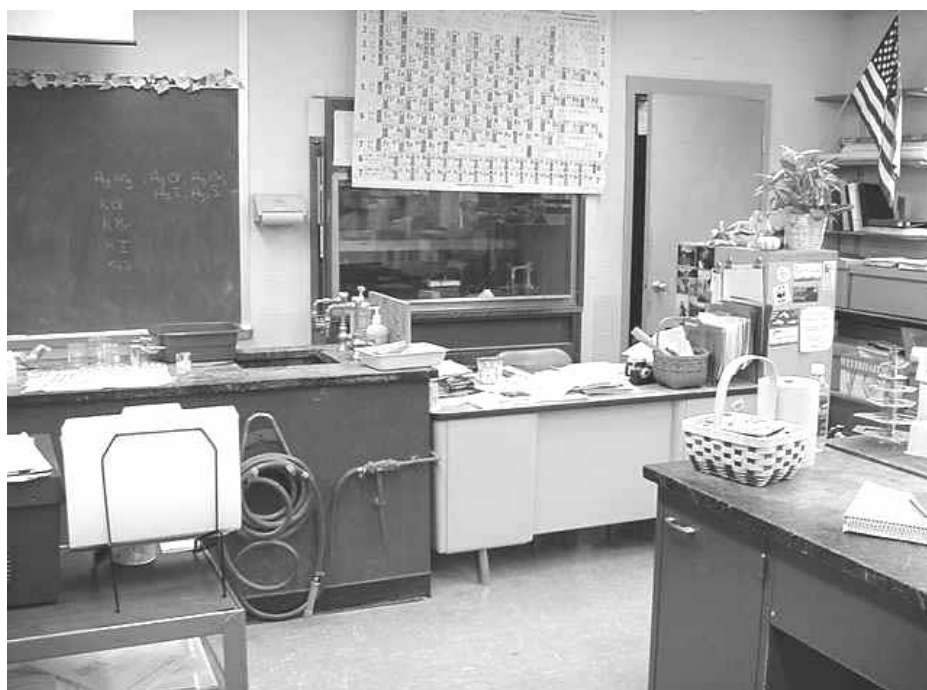
Picture 3

Several conditions that can potentially affect indoor air quality were also identified. Of note is the design of the ventilation system for the chemical storage area. It appears that this area was designed to have air exhausted via a chemical hood (see Picture 3). The chemical hood was deactivated during this assessment. In order to provide an adequate air supply from the interior of the building (called transfer air, i.e., air that is transferred from one area to another), it appears that a passive vent was installed in the interior hallway wall (see Picture 4) to allow for adequate operation of the chemical hood. This design can prevent odors and vapors from stored chemicals which may evaporate in the chemical storeroom if the chemical hood is operating. Since the chemical hood is deactivated, possible odors and vapors from the chemical storeroom can enter the hallway through this vent or adjacent classrooms through interior doors. To avoid this circumstance, the chemical hood should operate continuously.

Chemical Hood

3. Ensure the mechanical ventilation system is properly balanced by an HVAC engineering firm once renovations are complete.
4. Operate the chemical hood continuously.

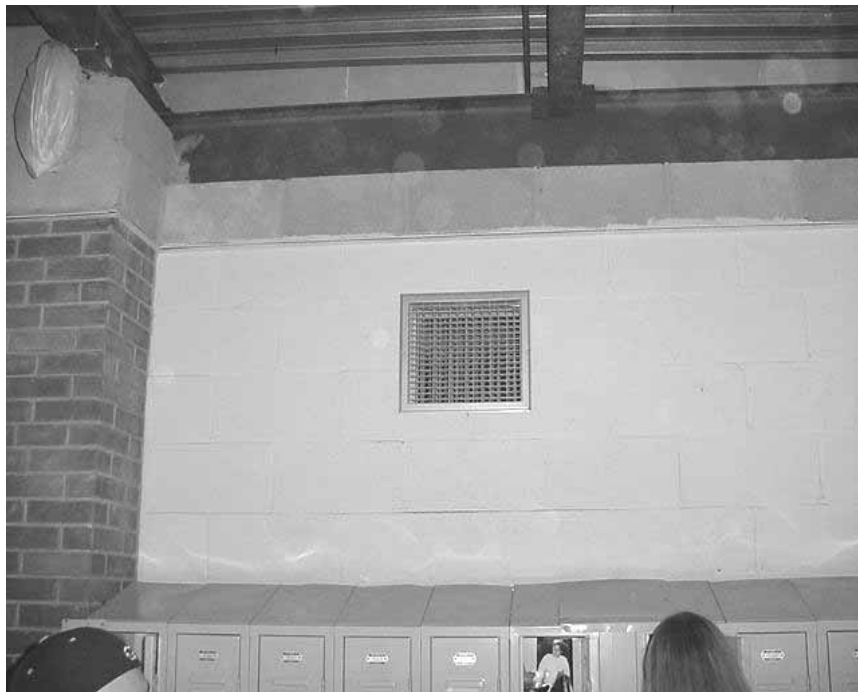
Picture 4

Transfer Air Vent for Chemical Storeroom

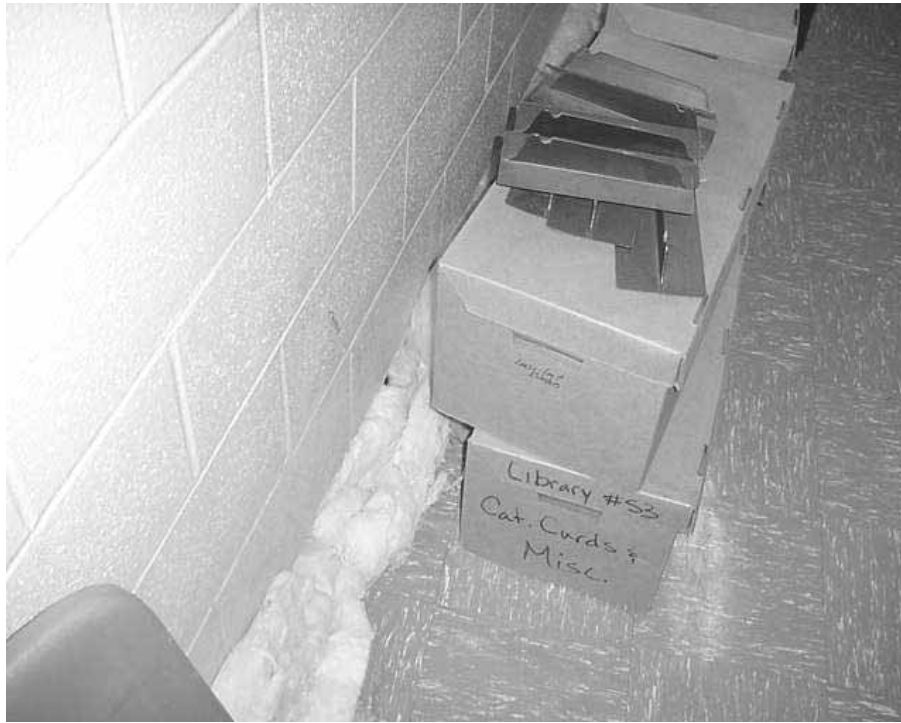
Picture 5

Exposed fiberglass insulation was used to block airflow from renovation sites into occupied areas (see Picture 5). Also of note was the amount of materials stored in some areas. In many classrooms and common areas, items were seen piled on windowsills, tabletops, counters, bookcases and desks. The large amount of items stored provides a means for dusts, dirt and other potential respiratory irritants to accumulate. These stored items (e.g., papers, folders, boxes, etc.) also make it difficult for custodial staff to clean. Household dust and fiberglass particulates can become easily aerosolized and serve as a source of eye and respiratory irritation. In addition, fiberglass insulation material can also serve as a source of skin irritation to sensitive individuals.

Fiberglass insulation used as air plug

8. Encapsulate exposed fiberglass in occupied areas; consider covering with plastic sheeting and securing with duct tape.
9. Relocate or consider reducing the amount of materials stored in classrooms to allow for more thorough cleaning of classrooms. Clean items regularly with a wet cloth or sponge to prevent excessive dust build-up.

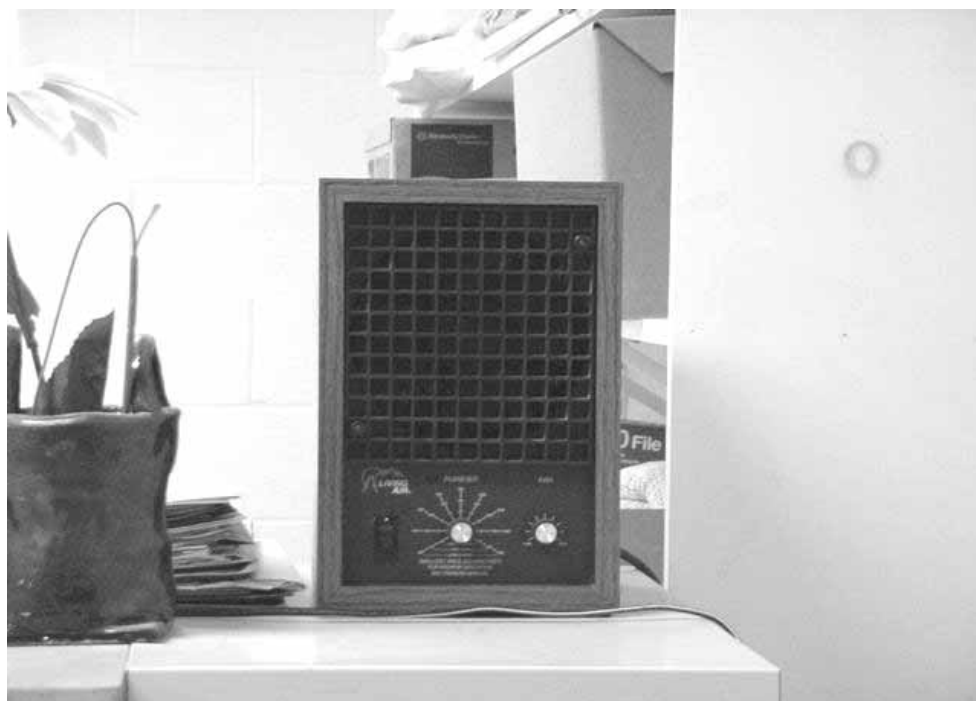
Picture 6

Ozone generator

5. Replace the ozone generator in the nurse's office with a stand-alone air filter device equipped with a high efficiency particulate arrestance (HEPA) filter. Consider acquiring a device that meets manufacturer's standards for air filtration, such as those standards set forth by the Association of Home Appliance Manufacturers (AHAM), which has set forth a room cleaner certification program for measuring the performance of portable air cleaning devices (US EPA, 2002).

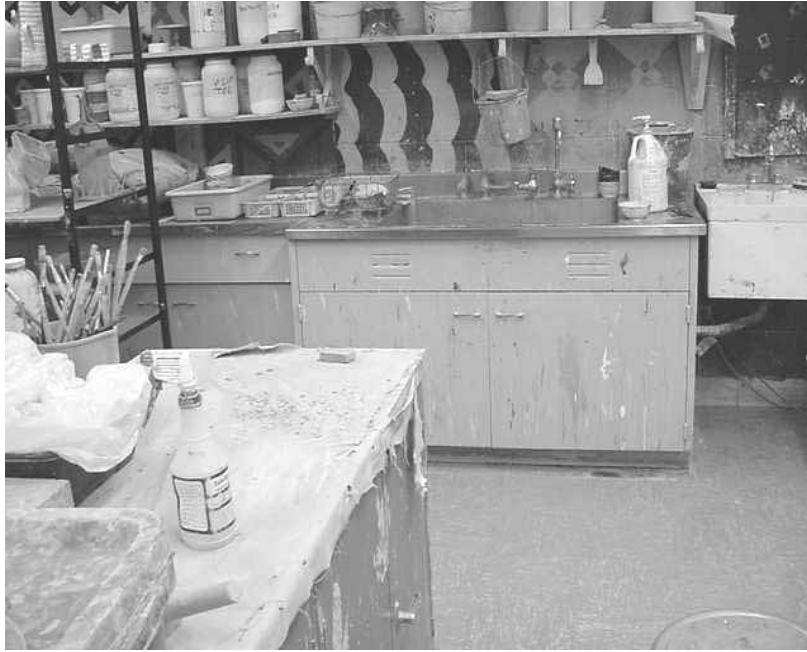
Picture 7

The floor and walls of the art room were stained with clay dust and residue (see Pictures 7 and 8). The most notable stains were located around pottery wheels. Water and

wet clay spinning off the wheel had coated the floor. Clay dust can be an eye, nose and throat irritant.

Clay Dust and Water Damage in Art Room

6. Wet mop the floor in pottery wheel room immediately after use to control clay dust accumulation.
7. For buildings in New England, periods of low relative humidity during the winter are often unavoidable. Therefore, scrupulous cleaning practices should be adopted to minimize common indoor air contaminants whose irritant effects can be enhanced when the relative humidity is low. To control for dusts, a high efficiency particulate arrestance (HEPA) filter equipped vacuum cleaner in conjunction with wet wiping of all surfaces is recommended. Drinking water during the day can help ease some symptoms associated with a dry environment (throat and sinus irritations).

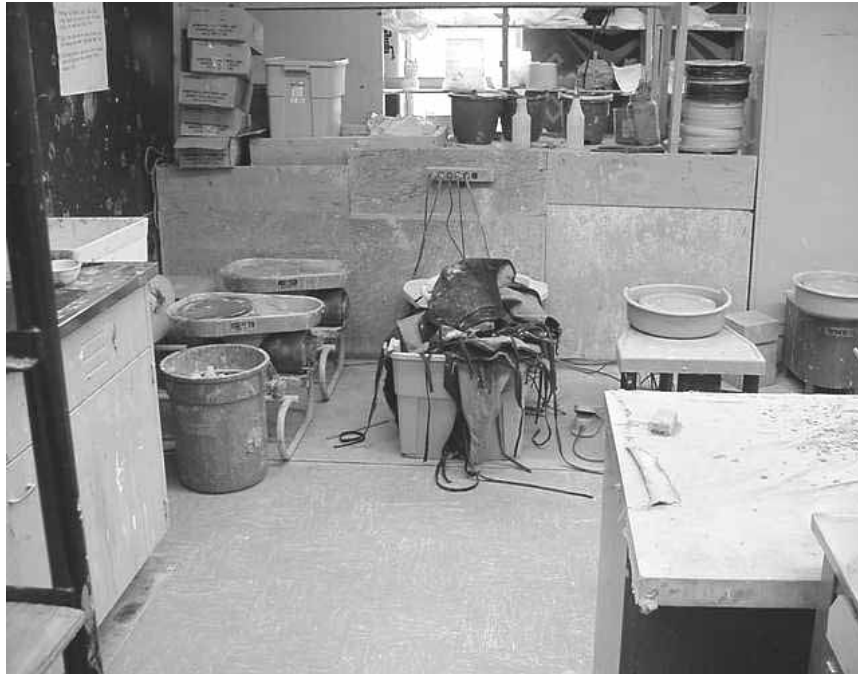
Picture 8

Clay Dust and Water Damage in Art Room

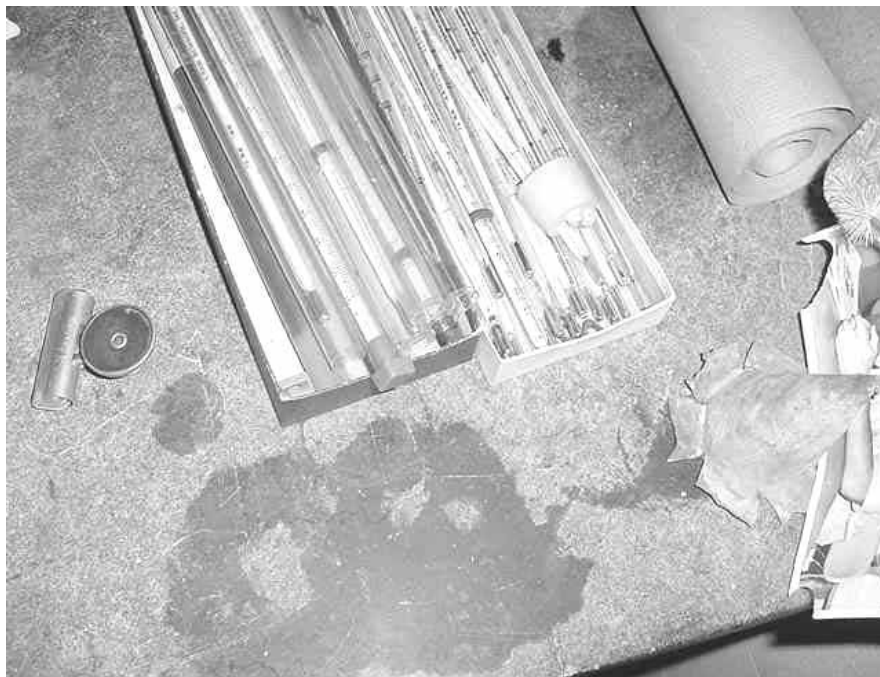
Picture 9

The storage closet of the science classroom had a number of mercury filled thermometers (see Picture 9). Breakage of these glass thermometers can result in an accidental discharge of mercury within the classroom environment.

Mercury Containing Thermometers

10. Consider installing local exhaust ventilation in teacher's workroom to remove excess heat and odors.
11. Replace mercury-containing thermometers. Dispose of mercury containing thermometers in a manner consistent with Massachusetts hazardous waste disposal laws.

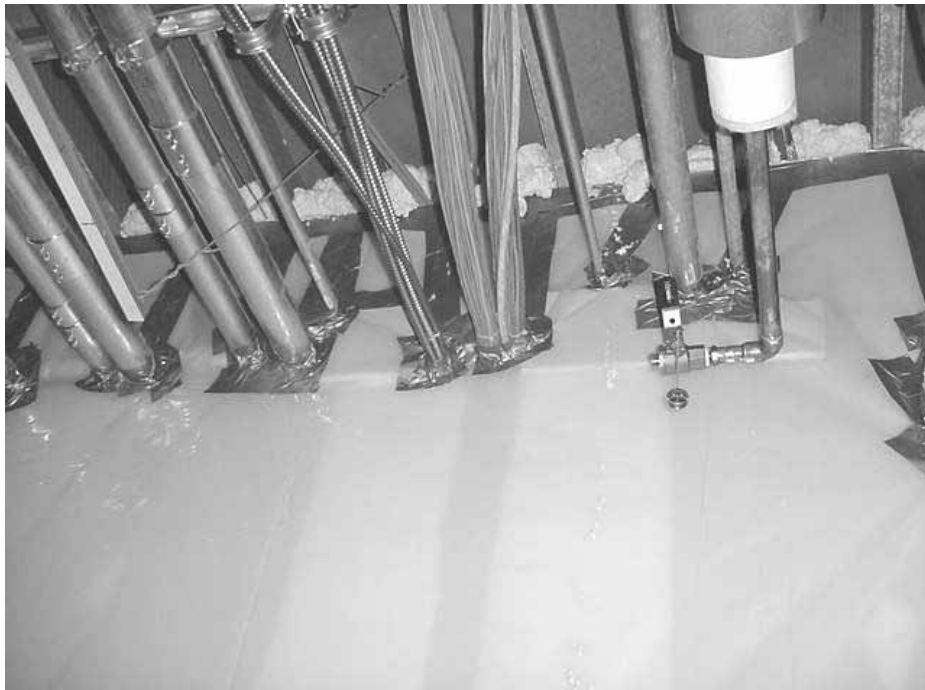
Picture 1

Pipe Penetrations Sealed with Duct Tape

8. Seal utility holes, spaces in and around temporary walls and holes created by missing ceiling tiles to eliminate pollutant paths of migration.
9. Seal all doors that access renovations with polyethylene plastic and duct tape.

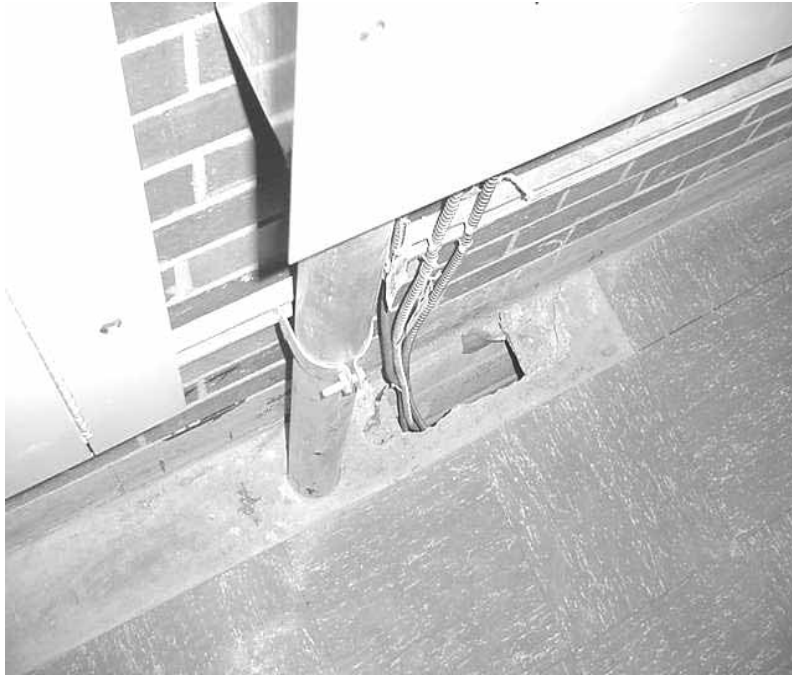
Picture 2

Unsealed Hole in Floor

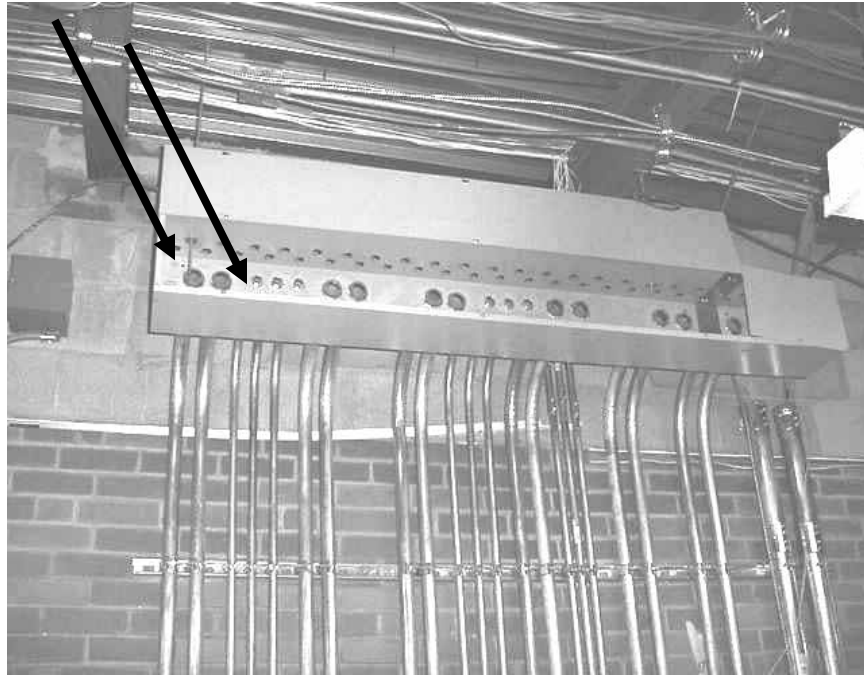
Picture 3

Uncapped Electrical Conduits

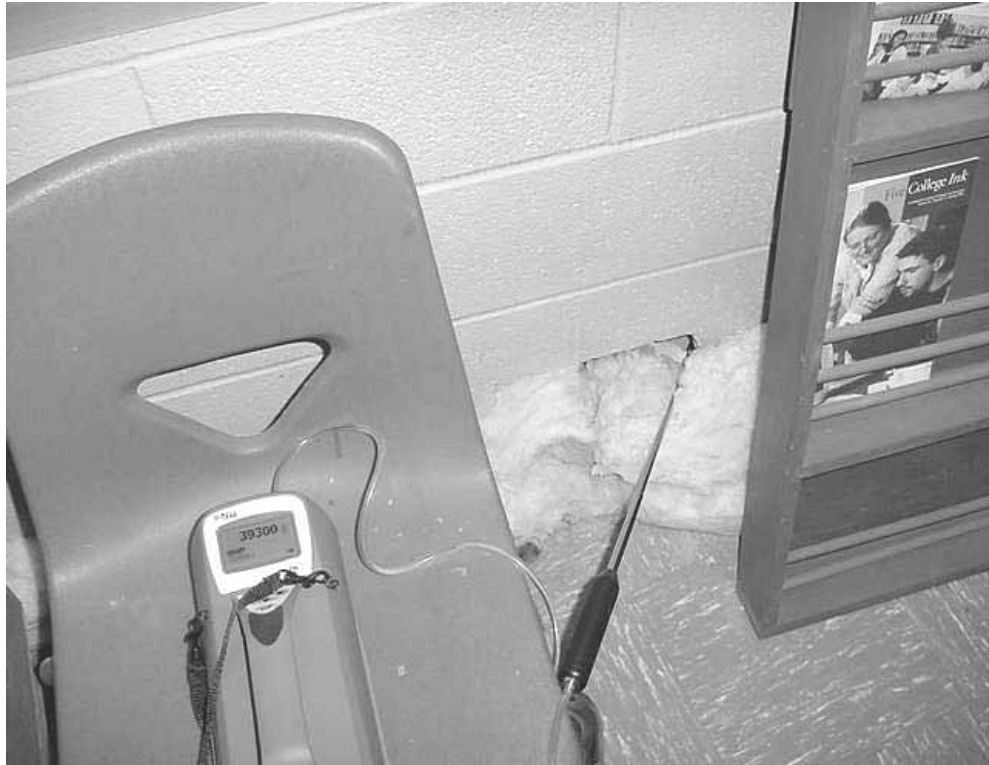
Picture 5

Fibrous Glass Used as a Plug in the 300A Hallway
